## **Projects undertaken directly by DDA:**

### **Preparation and implementation of Conservation Management Plan of Mehrauli Archaeological Park.**

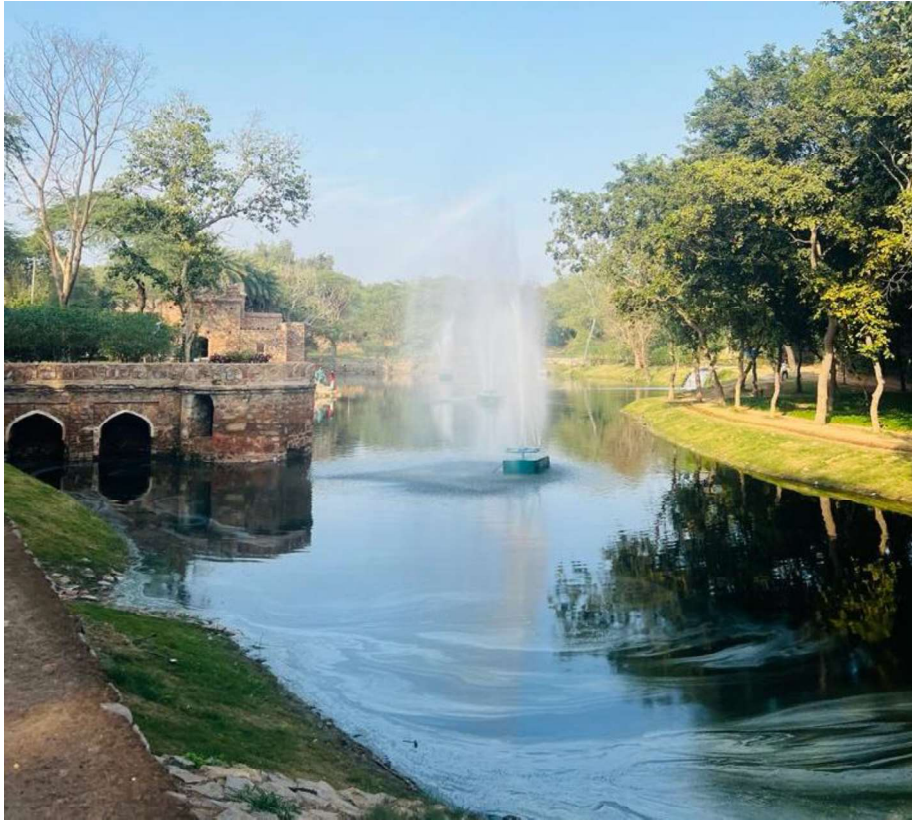
- Rejuvenation of water body.

Earlier, the water body on the eastern side of Quli Khan Tomb and flanked by the Boathouse was full of silt, debris and was dry. Even though historically this water body was used by Thomas Metcalf (the Resident Commissioner of Delhi in 1840) as boating and recreation area flanked by a Boathouse, a Horse Carriageway, Circular Dining Room and a Rose Garden; over the years, due to continuous siltation from the catchment areas such as Qutb Minar and adjoining undulating slopes and no proper upkeep had reduced it to a small ditch which remains dry perennially.

Now, the waterbody has been rejuvenated and the surroundings are cleaned up and new plantation have been carried out. Desilting and removal of debris were taken up on priority basis. The arches under the horse Carriageway were restored to original condition as per conservation principles. The historical water culvert under the Horse carriageway has been reopened and restored allowing water from the surrounding catchment areas to flow into the water body, as it functioned before. Random rubble stones as available in site were rammed onto earth at select locations of slopes to prevent soil erosion. No cement or lime concrete has been used in these stone pitching. Soils brought by natural waterflow are allowed to fill the voids and grow grasses and vegetations. Continuous source of water from DJB (Delhi Jal Board) now fills the water body and aerator fountains have been installed for purifying the water – which now converts the dry waterbody to a permanent waterbody, allowing a micro climate to thrive naturally, suitable for local flora and fauna.
