Works completed by DDA under the guidance of Hon'ble LG, Delhi

Restoring Heritage and Reviving Nature: The Success Story of Mehrauli Archaeological Park

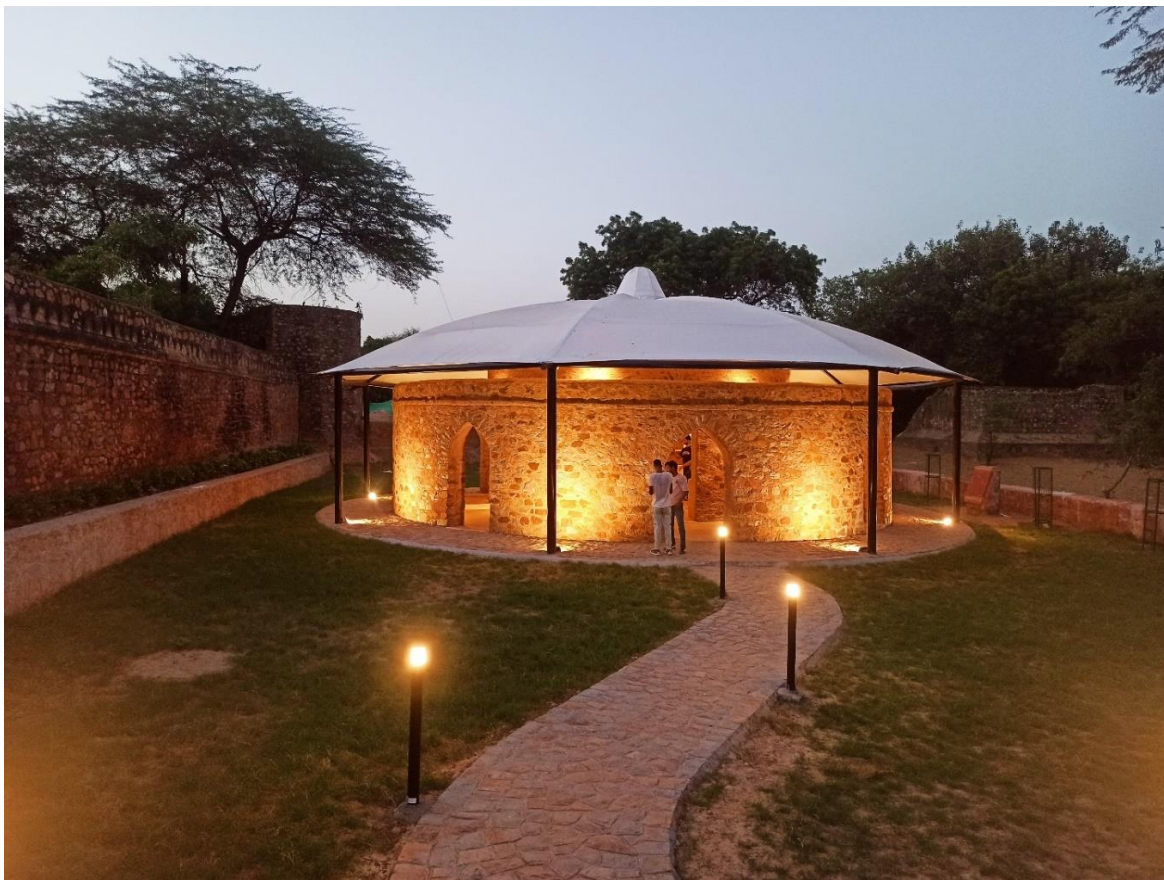
1. The Unknown Circular Monument: A Café of History and Beauty

Among these landmarks, the Circular Monument stood out as a symbol of both heritage and innovation. Its restoration was a testament to the commitment of DDA. The Circular Monument was painstakingly restored to its former glory while preserving its original structure. A beautiful cafeteria now graces its premises, offering visitors a taste of history and culinary delights.

Surrounded by meticulously designed landscaping and shaded with carefully chosen foliage, the Circular Monument has become a place where the past and present coexist harmoniously. Warm and inviting illumination casts a gentle glow and enhances its allure, revealing the intricate details of the monument even after sunset. The DDA's Civil, Horticulture, Electrical & Architectural wings worked tirelessly to bring this vision to life and The Circular Monument now stands as a picturesque oasis, offering a welcoming space for visitors to savor the park's heritage.

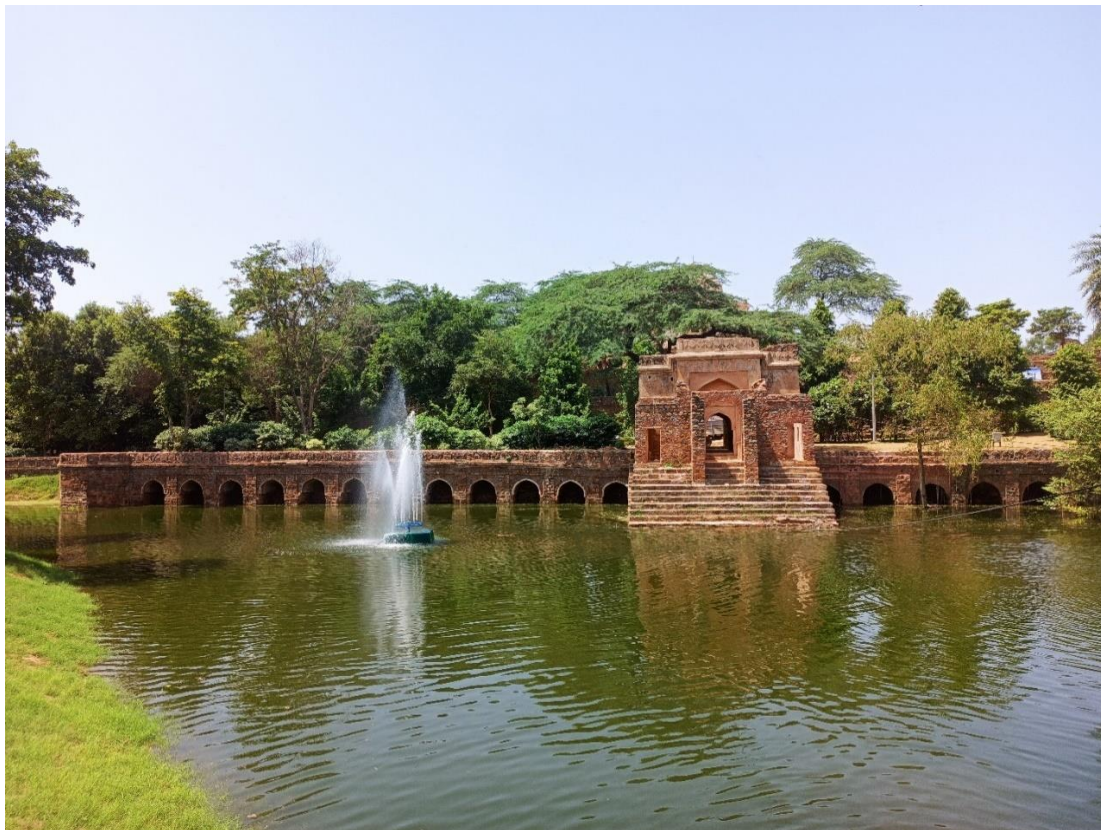
2. Metcalf Boat House: A Return to Authenticity

The Metcalf Boat House, once hidden beneath layers of silt and ravaged by time, has been painstakingly restored to its original glory. Both the main structure and its beautiful arches and stairs, previously obscured, have been meticulously rehabilitated. The arches, once hidden from view, are now exposed and brilliantly illuminated. The Metcalf Boat House has been reborn as the boat house it was meant to be, an embodiment of history and a reminder of its grandeur.

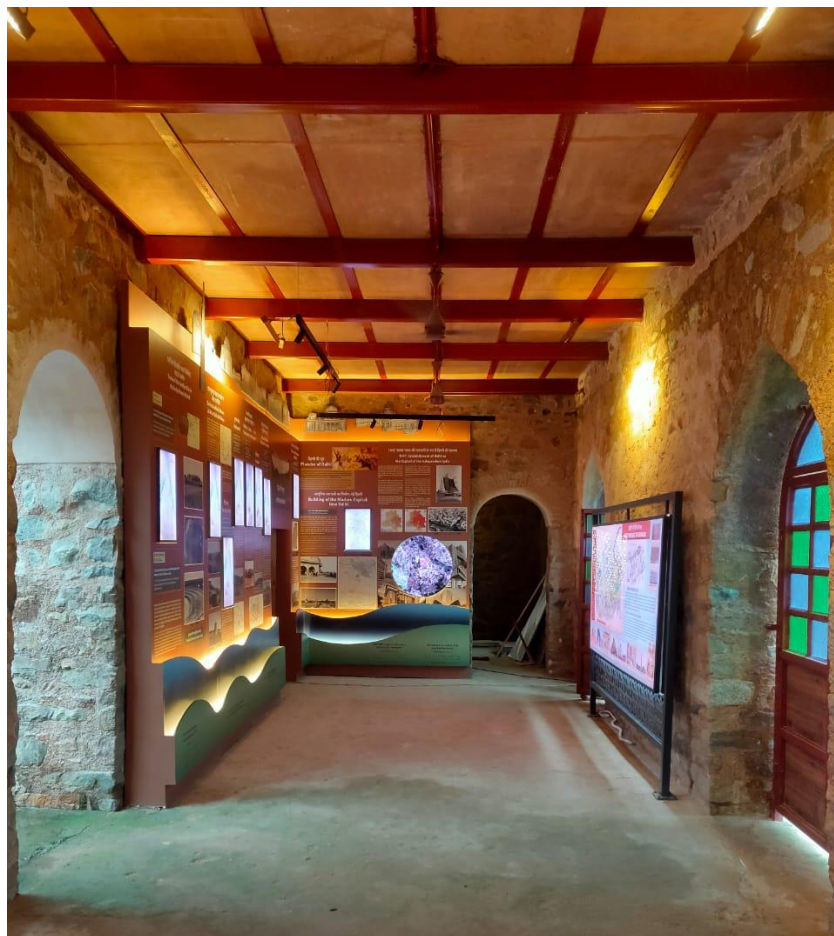
Figure 1 Gallery 1- Metcalfe Interpretation Centre

The interpretation center is designed into various galleries with innovative backlit illuminated descriptive panels along with archival photographs emphasizing on the rich heritage of the Mehrauli and Delhi City. The Gallery 1 – *Kahani Delhi ki* talks about the rich heritage and various historic cites of Delhi. The Gallery 2 – *Sufiyana* describes the rich sufi history of Mehrauli Village including the Dargah of Bakhtyar Kaki , Phool Walon ki Sair and other intangible aspects of Mehrauli. The Gallery 3 – *Zikr-e- Delhi* describes the heritage structures of the Mehrauli Village. The Gallery 4 discusses about the rich ecology of the area whereas the Gallery 5 describes the conservation and research initiatives taken in Mehrauli.

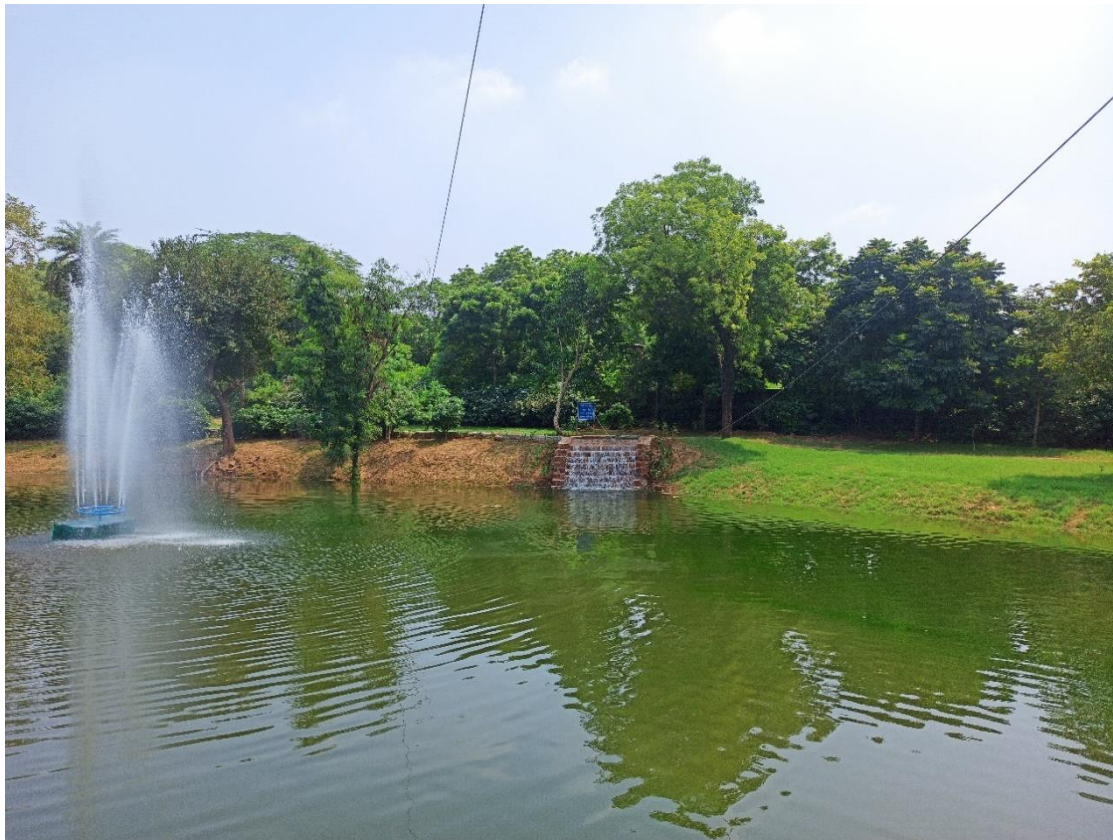
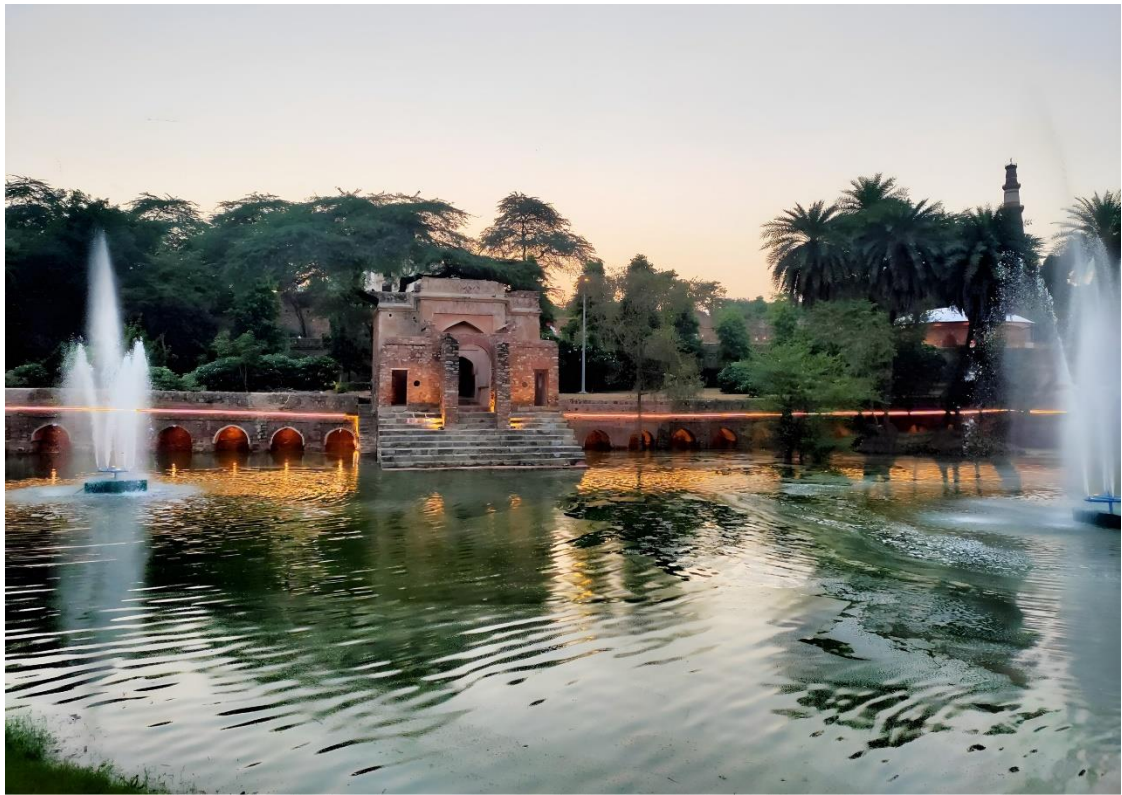
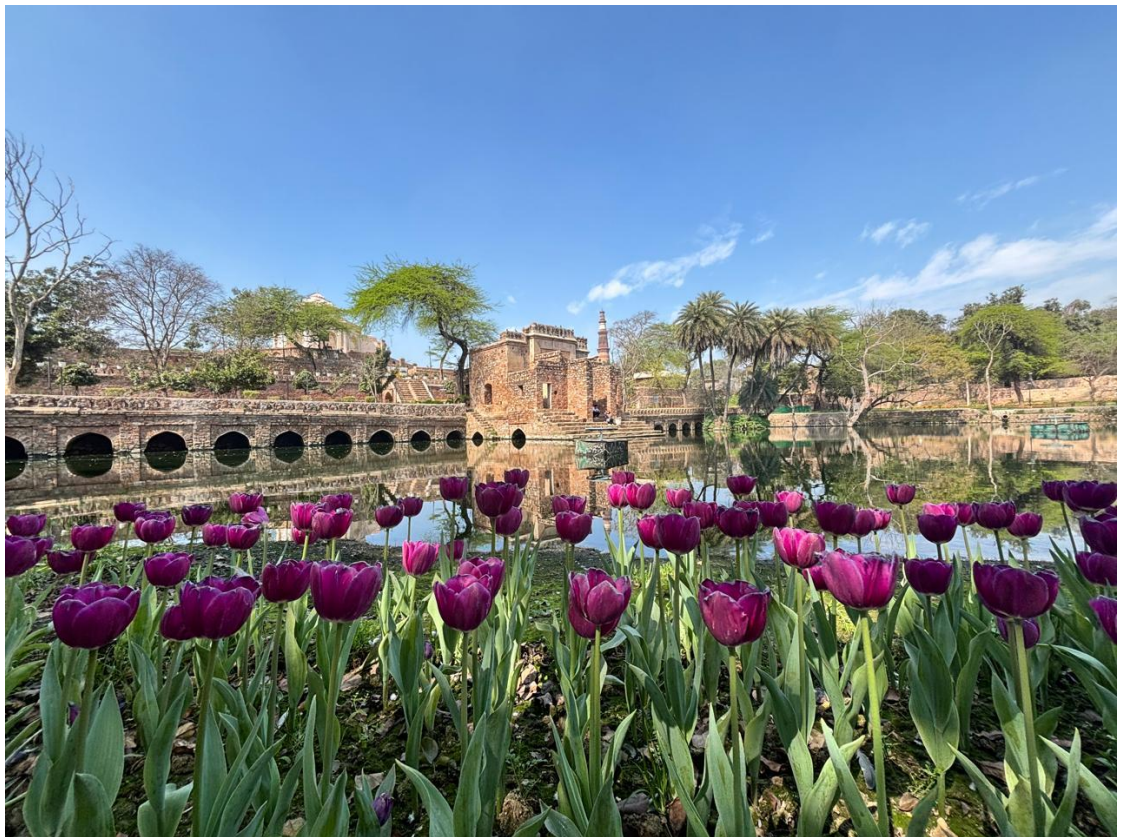
4. Rejuvenated Water Body near Metcalfe Boathouse : A Marvel of Restoration

Earlier, the water body on the eastern side of Quli Khan Tomb and flanked by the Boathouse was full of silt, debris and was dry. Even though historically this water body was used by Thomas Metcalf (the Resident Commissioner of Delhi in 1840) as boating and recreation area flanked by a Boathouse, a Horse Carriageway, Circular Dining Room and a Rose Garden; over the years, due to continuous siltation from the catchment areas such as Qutb Minar and adjoining undulating slopes and no proper upkeep had reduced it to a small ditch which remains dry perennially.

Now, the waterbody has been rejuvenated and the surroundings are cleaned up and new plantation have been carried out. Desilting and removal of debris were taken up on priority basis. The arches under the horse Carriageway were restored to original condition as per conservation principles. The historical water culvert under the Horse carriageway has been reopened and restored allowing water from the surrounding catchment areas to flow into the water body, as it functioned before. Random rubble stones as available in site were rammed onto earth at select locations of slopes to prevent soil erosion. No cement or lime concrete has been used in these stone pitching. Soils brought by natural waterflow are allowed to fill the voids and grow grasses and vegetations. Continuous source of water from DJB (Delhi Jal Board) now fills the water body and aerator fountains have been installed for purifying the water – which now converts the dry waterbody to a permanent waterbody, allowing a micro climate to thrive naturally, suitable for local flora and fauna.

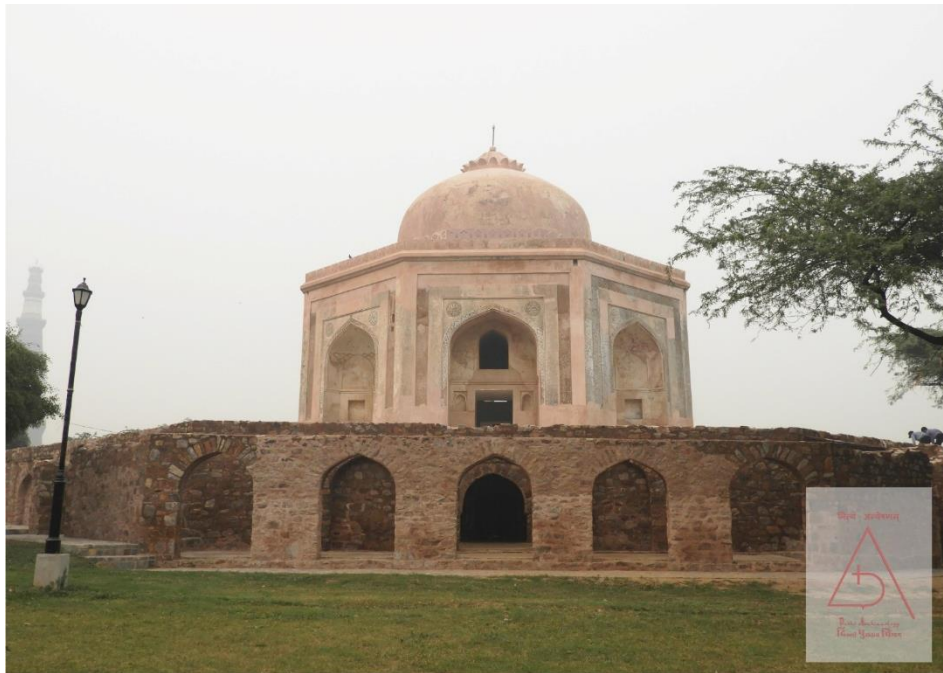
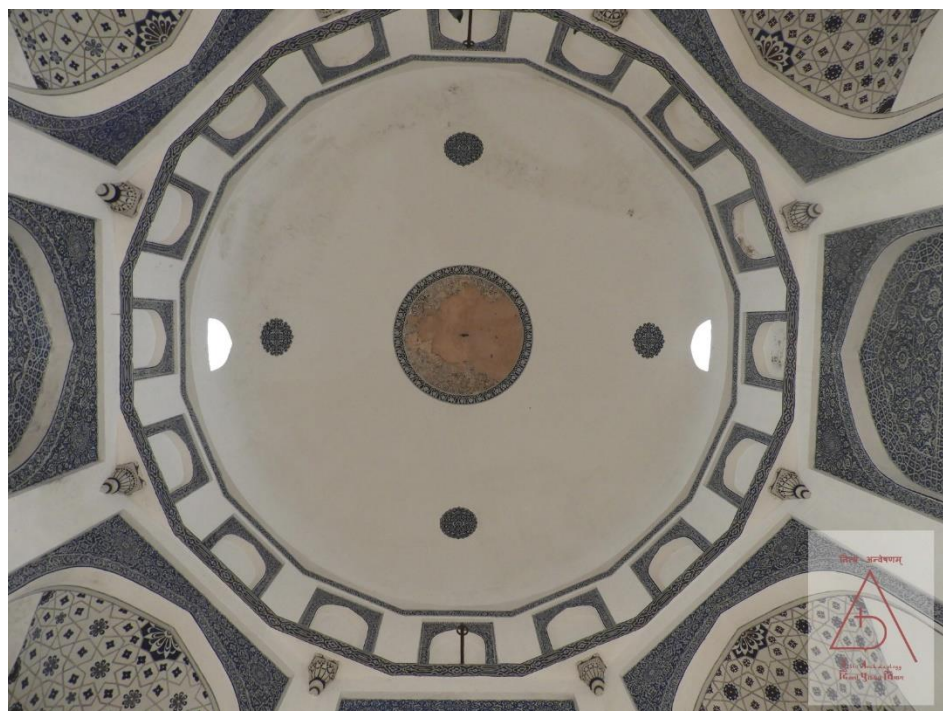
5. Quli Khan Tomb (Done by Dept. of Archaeology, GNCTD)

The tomb was constructed in the early 17th century by Emperor Akbar for his foster brother Mohd. Quli Khan. The tomb has been successfully restored by Dept. of Archaeology, GNCTD. The repair and conservation works included surface cleaning, re-plastering (wherever required), repointing of raked out joints of random rubble masonry, coping on parapet, stone consolidation (wherever required), flooring, terrace water proofing, plinth area protection and conservation of original stucco work.
